Zodiac Arresting Systems

Review of the Performances of EMAS Systems in Live Arrestments

August 2014

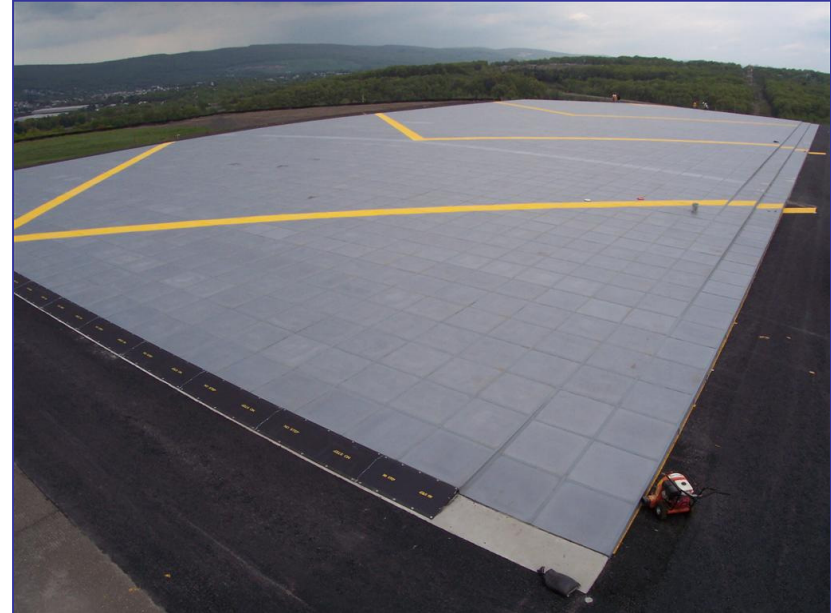
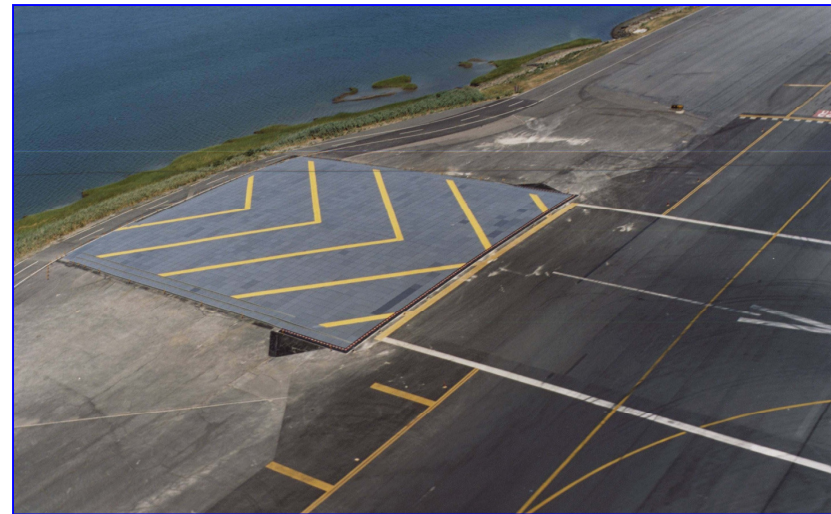
What is EMASMAX®

- A bed of cellular cement blocks encased in an environmental cover
- Passive, reliable, and predictable
- Providing gentle and consistent deceleration

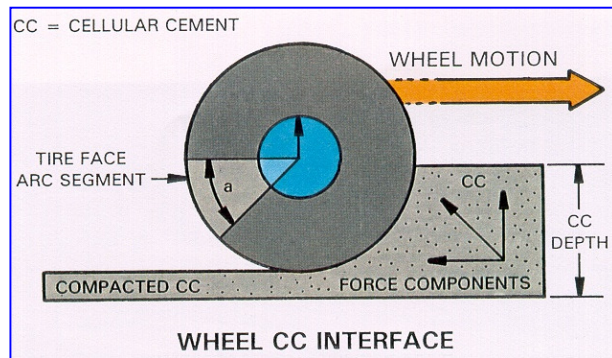
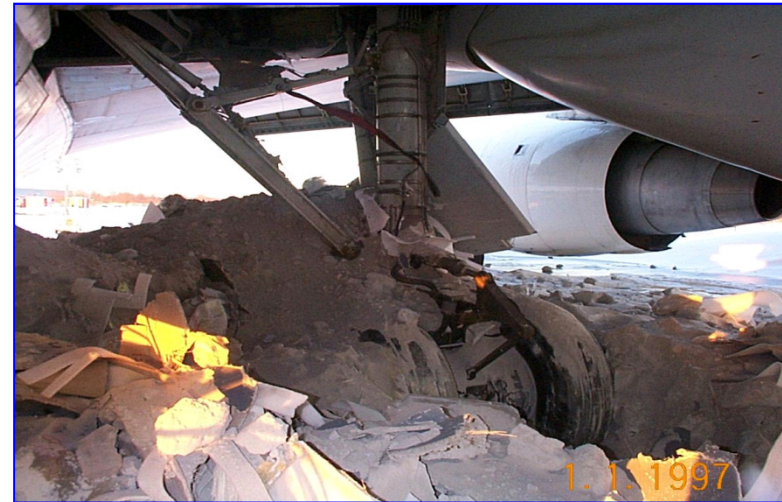
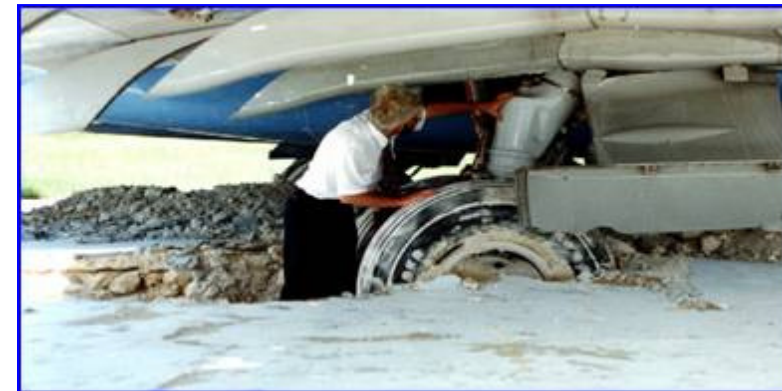
Theory of Operation

- Tire/material interface provides resistive loads to decelerate the aircraft
- Loads are placed on the aircraft landing gear and support structure
- ZASA's FAA-Approved computer model is used to determine final arrestor bed configuration

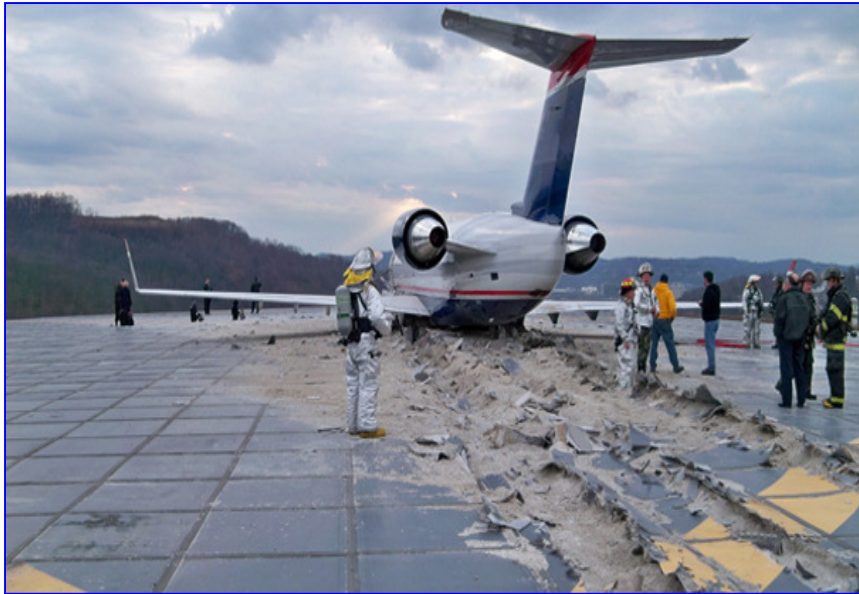
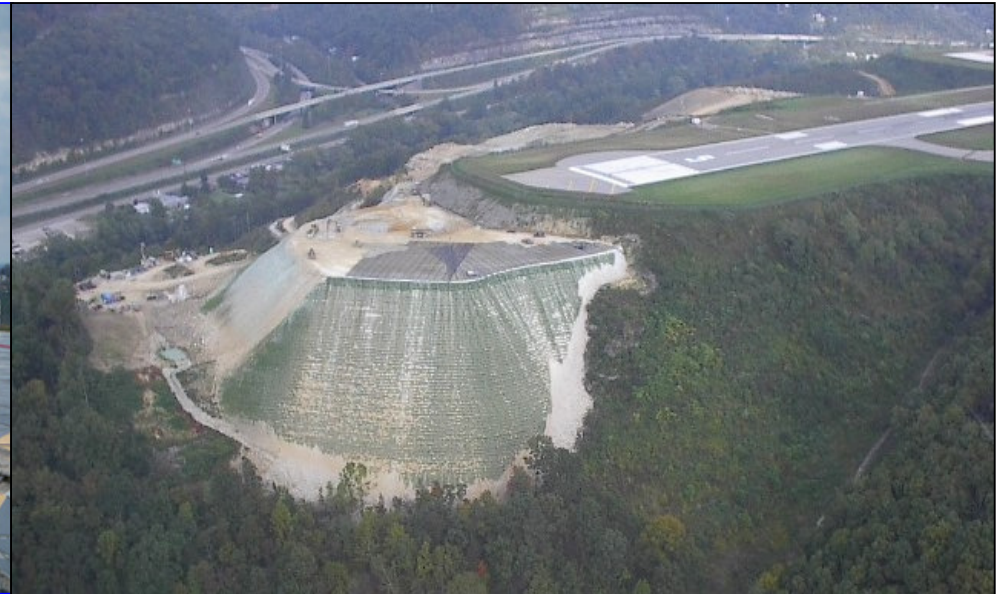
Charleston (CRW) Airport Arrestment

19 Jan. 2010: CRJ-200 regional jet, aborted takeoff, 50+ kts

**No injuries to 34
passengers and crew**

**Runway reopened within
5 hours**

**Aircraft returned to
service (3 days)**

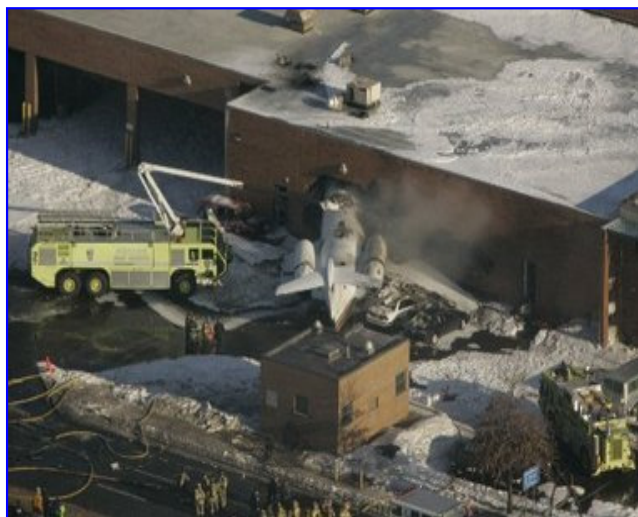
Prior to EMAS Installation -
Overrun
February 2005

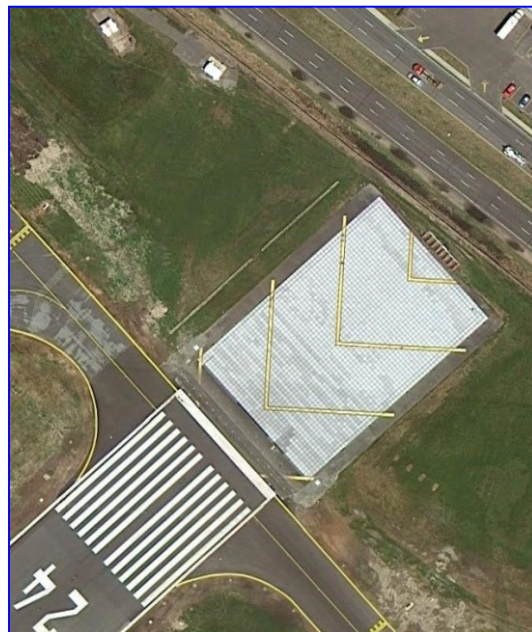
Teterboro, NJ Airport
Runway 06 Departure
EMAS Installed 2006

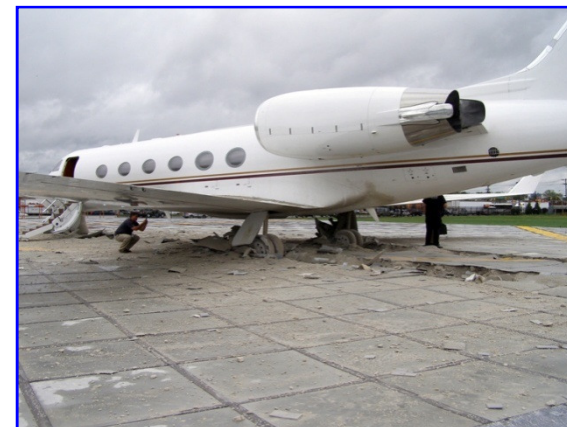
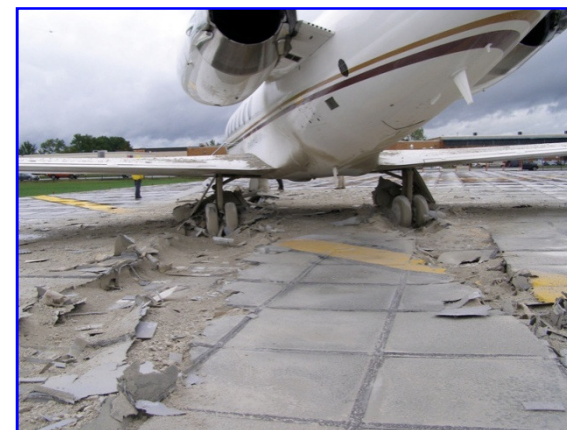
Arrestment
October 2010

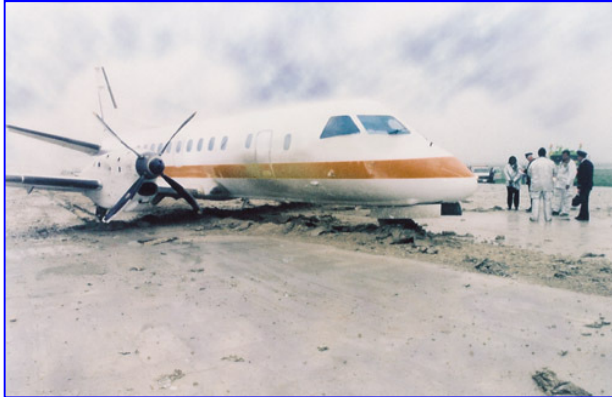
May 1999 – New York JFK 4R
SAAB 340 @ 70+ Knots

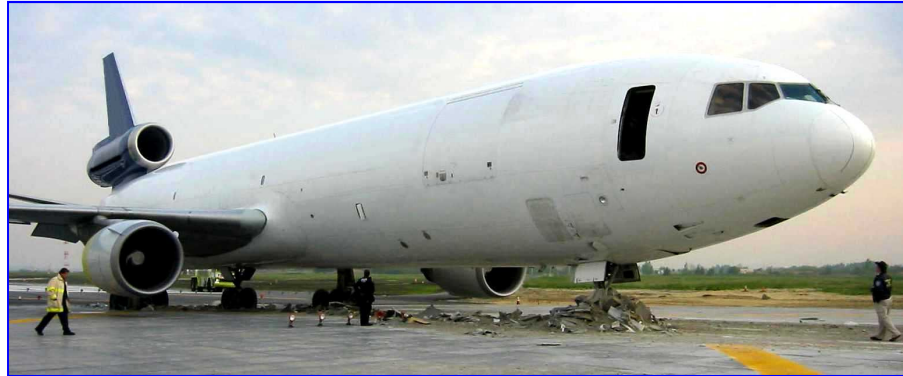
May 2003 – New York JFK 4R
MD11 @ 30+ Knots

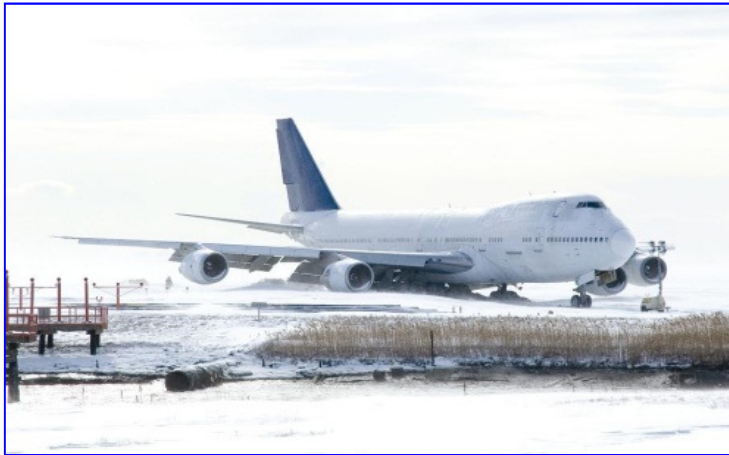
January 2005– New York JFK 4R
B747-200F @ 70 Knots

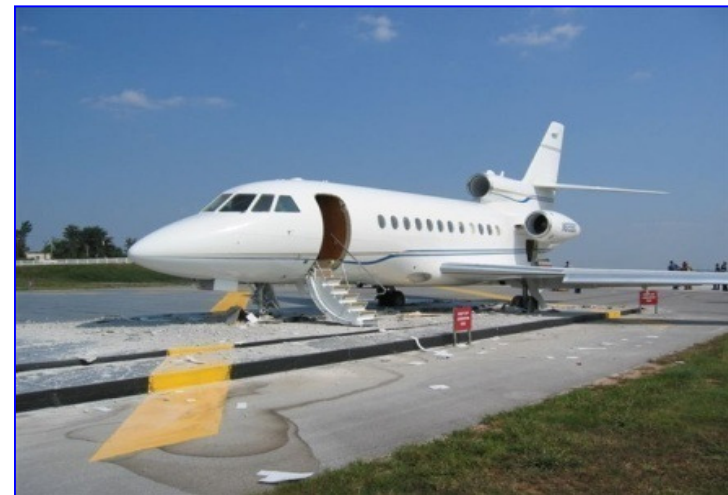
July 2005 – Greenville SC GMU 01
Falcon 900 @ 30+ Knots

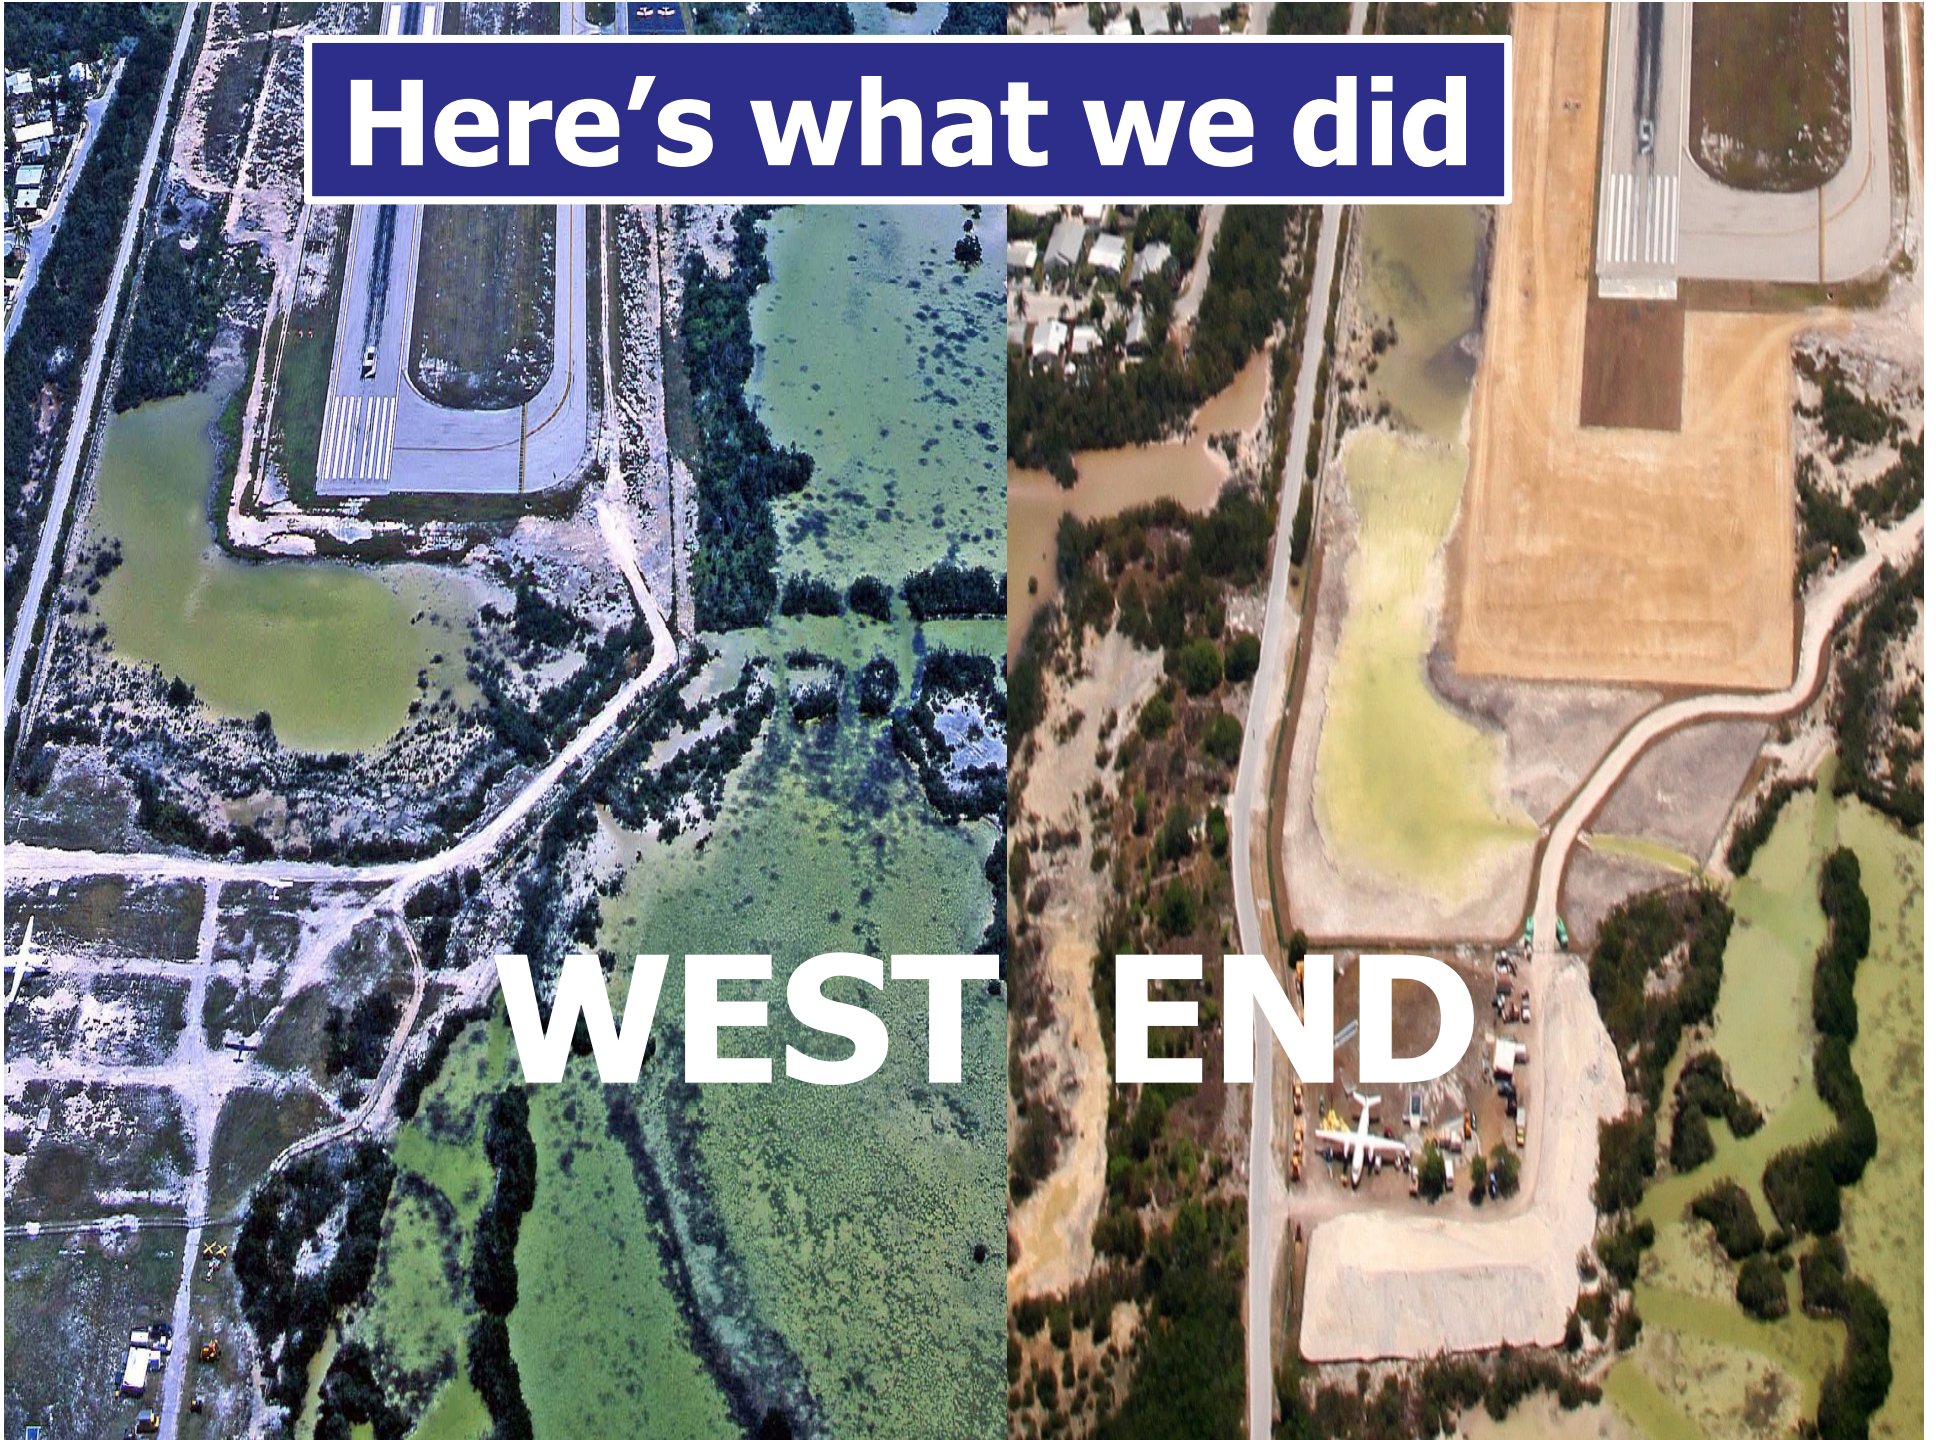
WEST END

**THE RUNWAY SAFETY AREAS IN
MAY OF 2011**

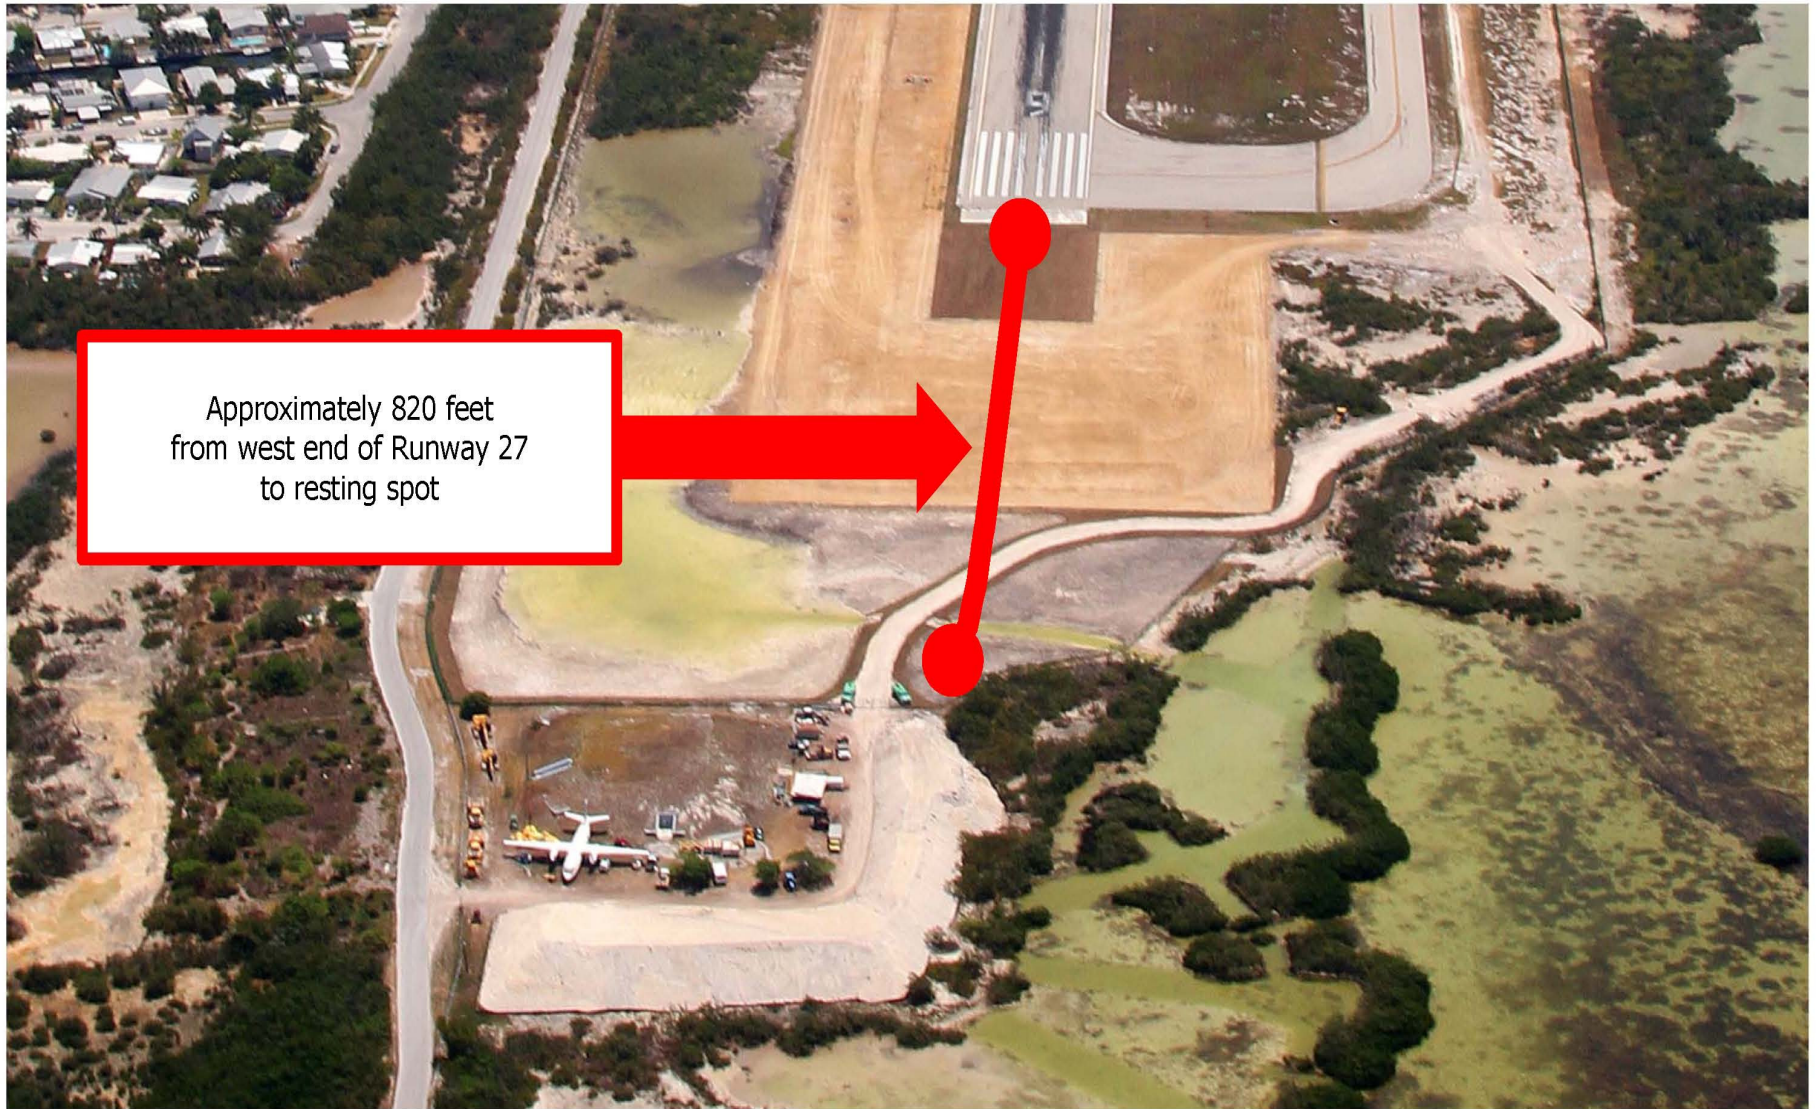
October 31, 2011 Aircraft Accident

Gulfstream G-150 – N480JJ
Jimmie Johnson Racing II, Inc. and
Hendrick Motorsports, LLC
EIR# 2012SO800005
